Wastewater Master Plan Summary Report

Town of Addison Wastewater System Master Plan

LNV Project No. 130306

October 16, 2017

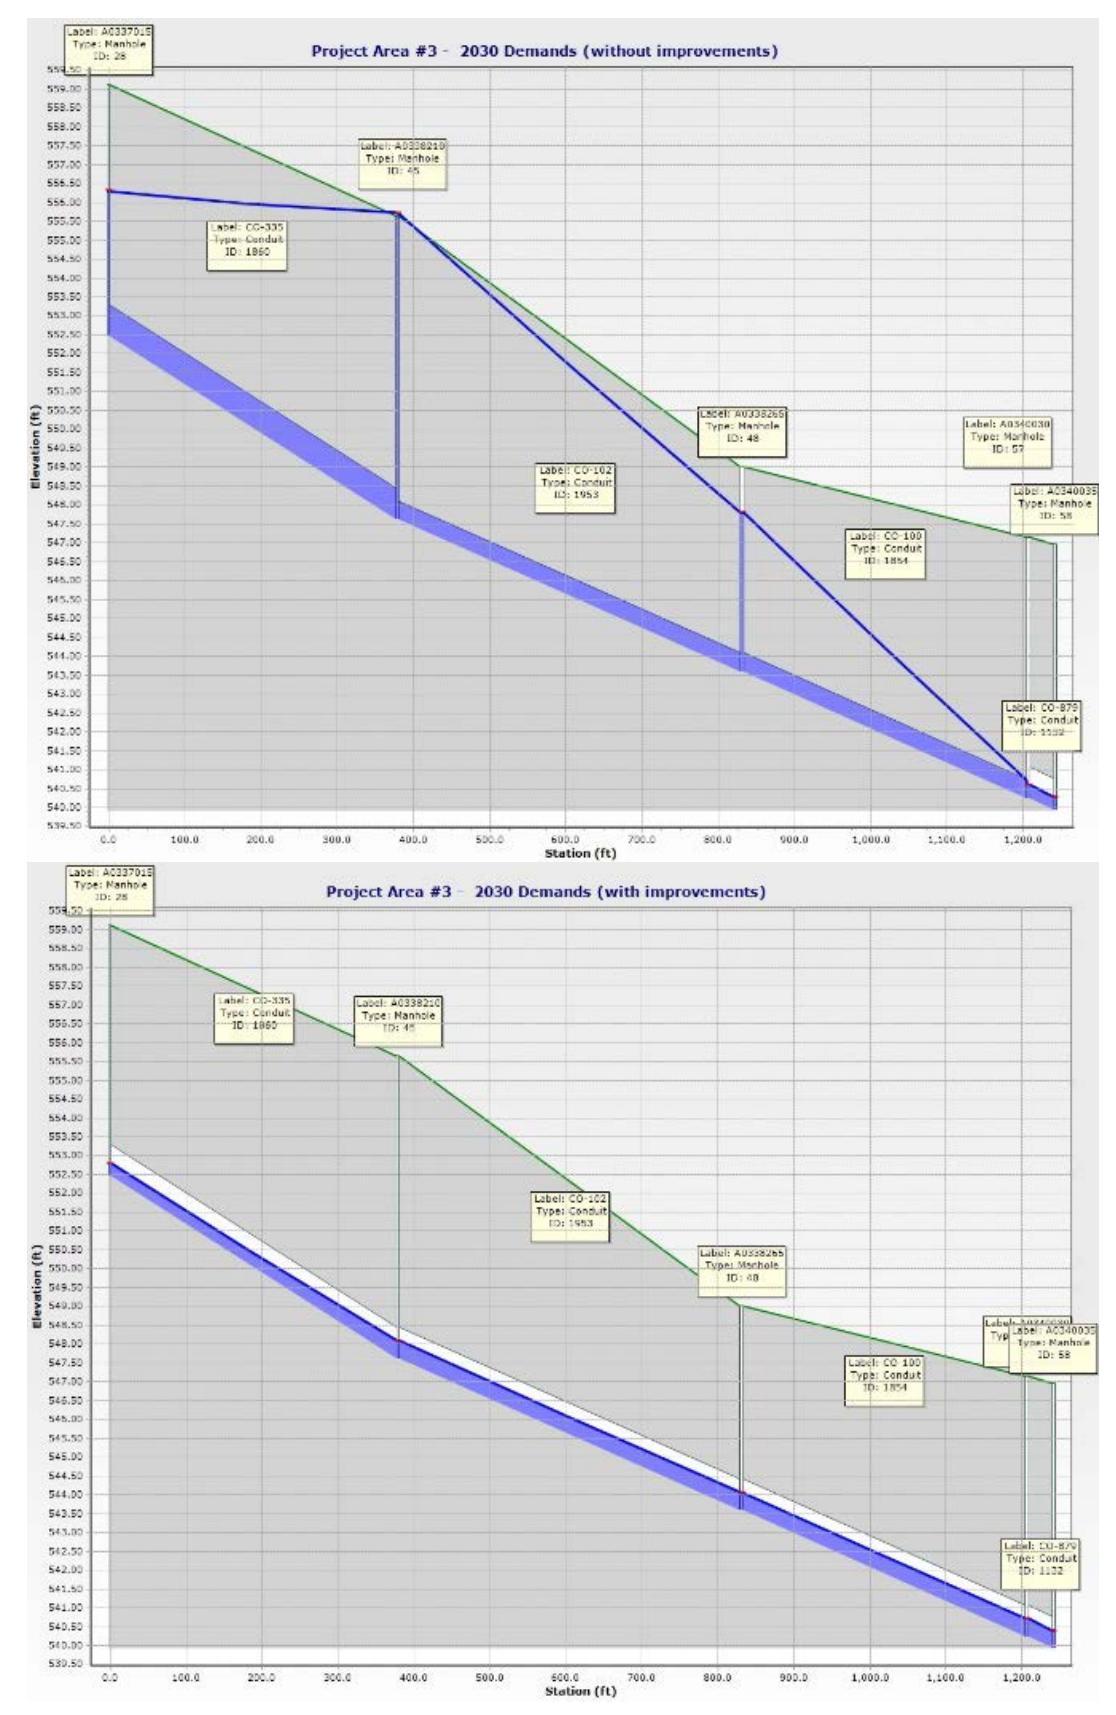
Figure 7: Profile Before and After Recommended Modeling Improvements

Some capacity issues identified in the hydraulic model evaluation effort consisted of known system capacity constraints or "bottlenecks" where a larger diameter pipe flows into a reduced diameter pipe causing flows to back up and fill upstream pipes and manholes. Other identified capacity issues were determined in horizon year conditions due to areas where large developments with aggressive growth are anticipated. The areas determined to have capacity issues were identified in the hydraulic model, as manholes which experienced hydraulic grade lines (HGL's) surcharging to within 3 feet or less of the manhole rim putting the manhole at risk of experiencing SSO's. Improvements to the hydraulic capacity of pipes downstream of these manholes were recommended and input into the model to ensure that the proposed improvement sufficiently remedied the hydraulic capacity issue (before and after modeled improvement for these capacity issues is to upsize the pipe by one or two commonly available pipe diameters utilizing the pipe-bursting method. The estimated cost to repair the hydraulic capacity issues identified during the modeling effort is summarized in **Table 11**.

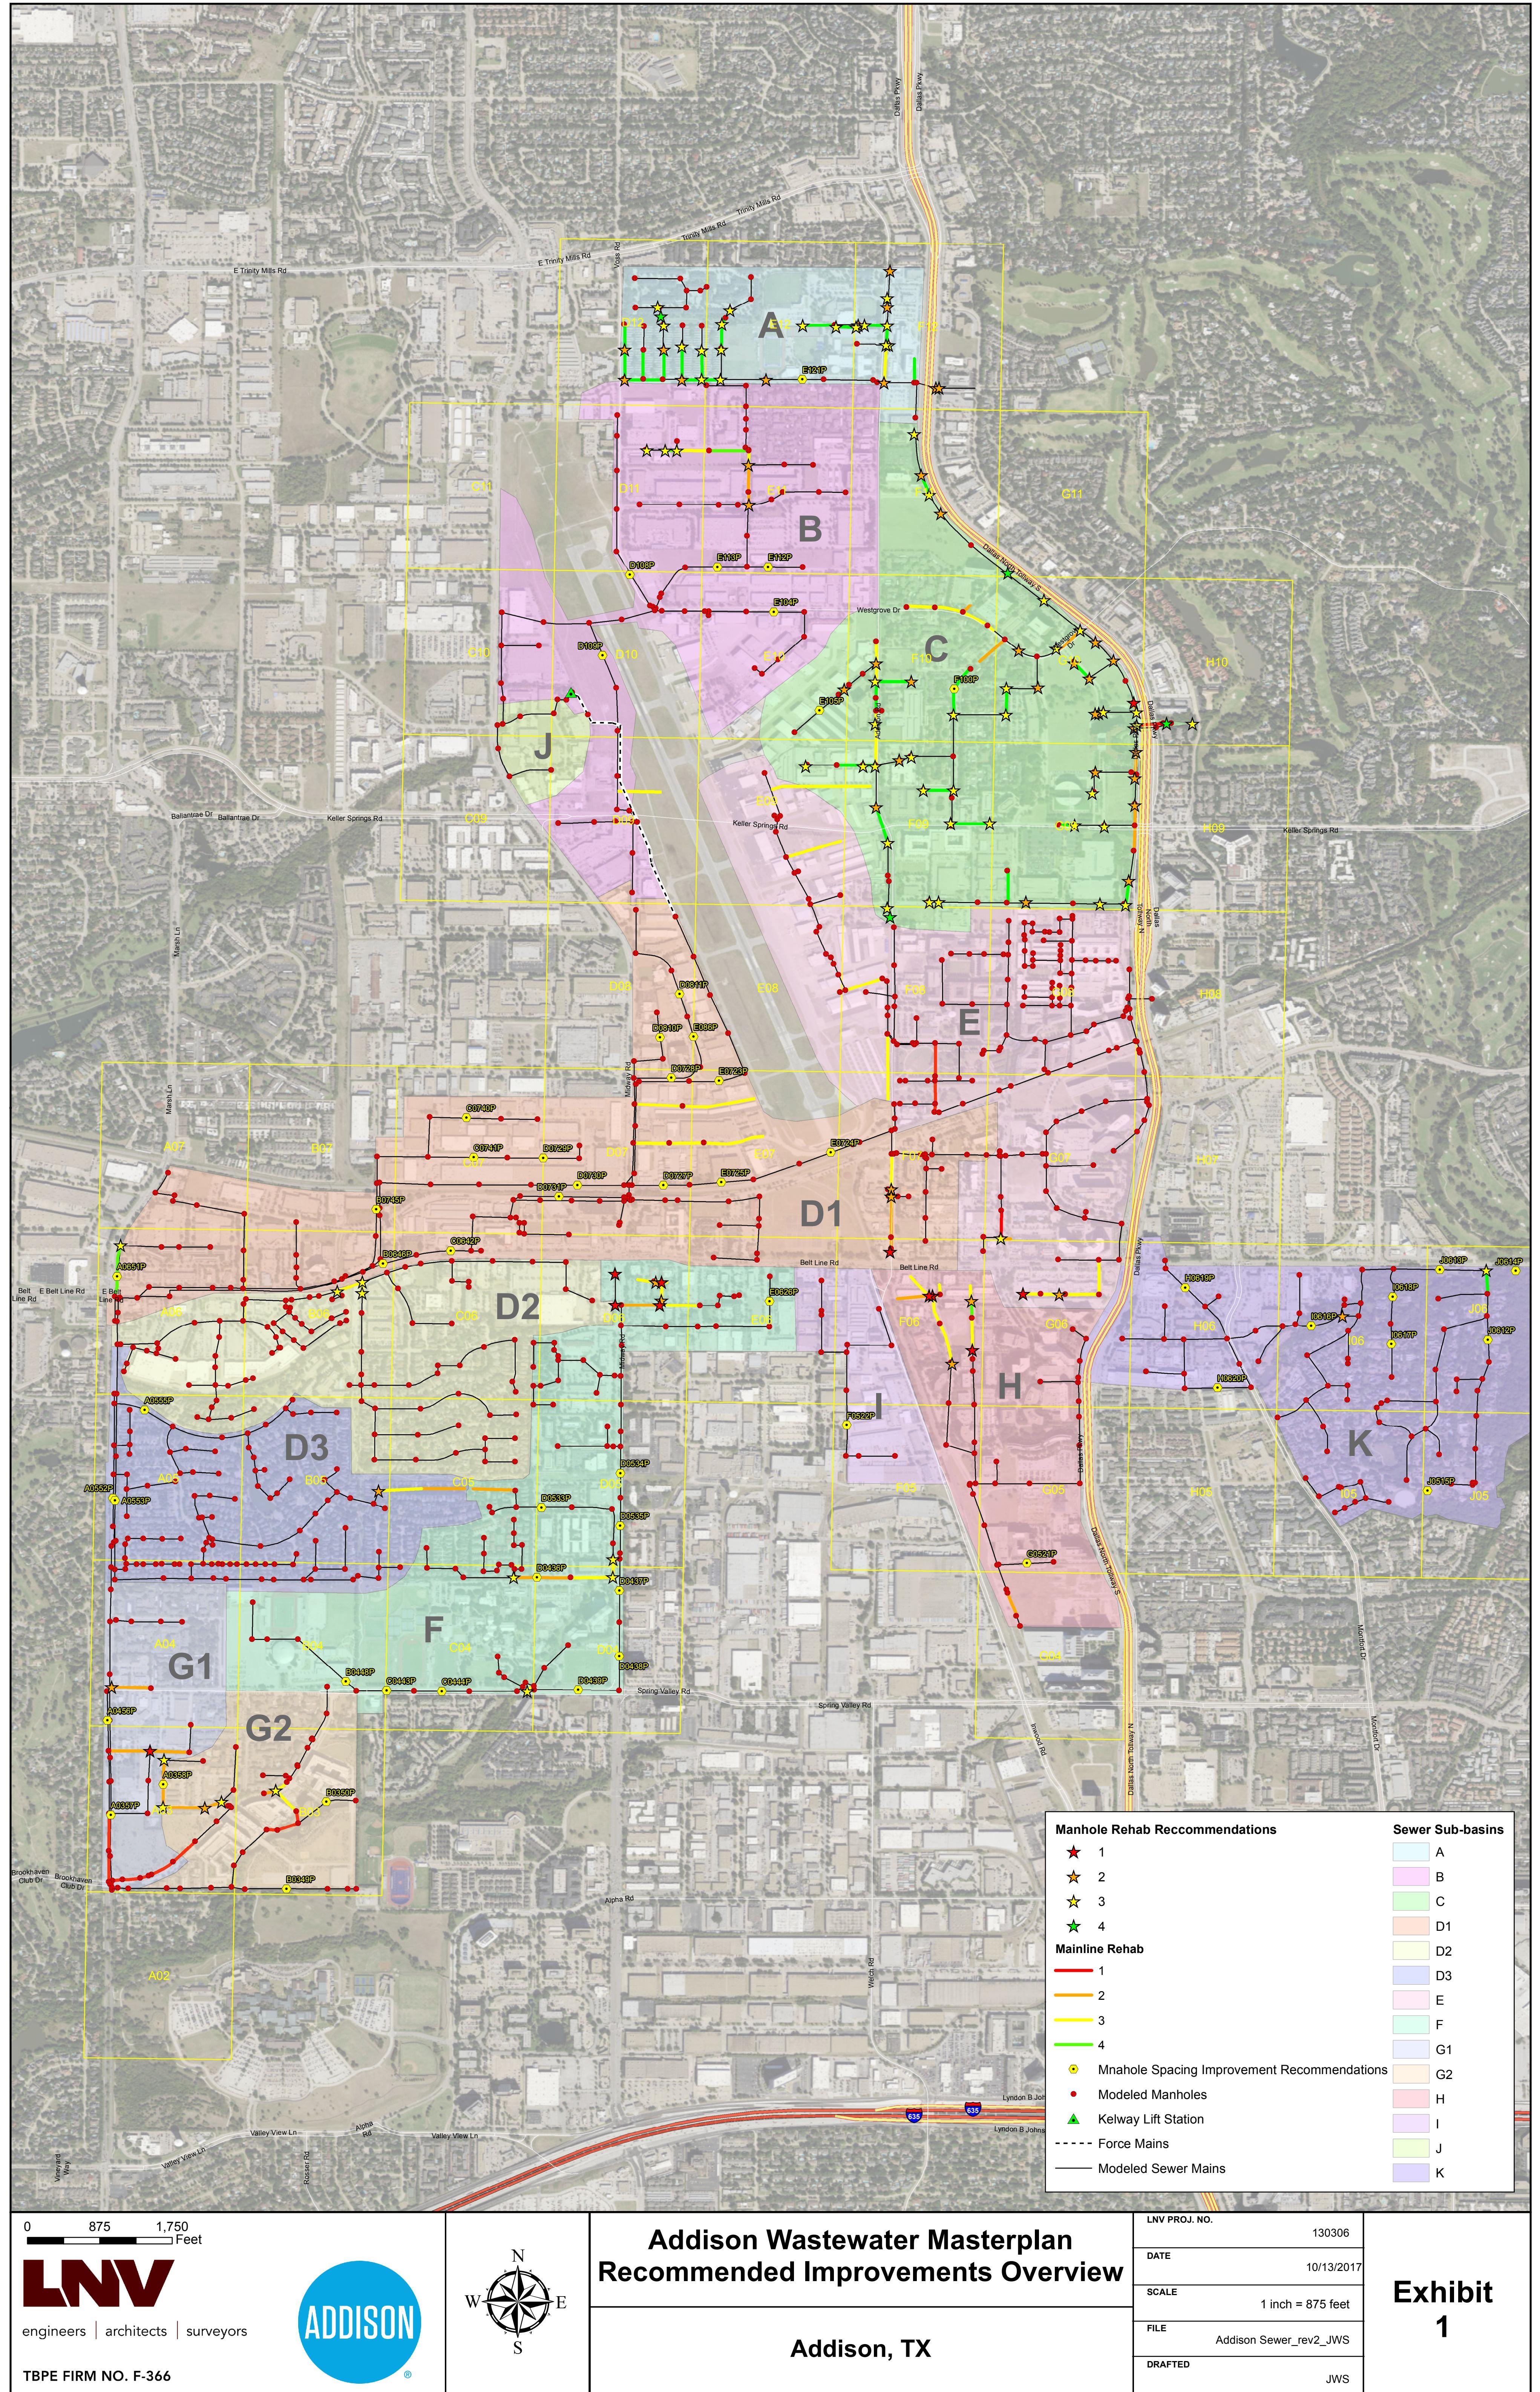
Exhibit 1

Overall, the ToA's wastewater system proved to be in very good condition with relatively few capacity improvements required considering the size of the collection system. A map showing all the recommended Capital Improvement Plan projects is presented in **Exhibit 1**.

Prioritized Improvement Overview

A map showing all of the recommended Addison Wastewater Master Plan CIP projects is illustrated in **Exhibit 1**. More detailed information about each specific project can be found in the CIP report and the other reports previously delivered under this scope of work.

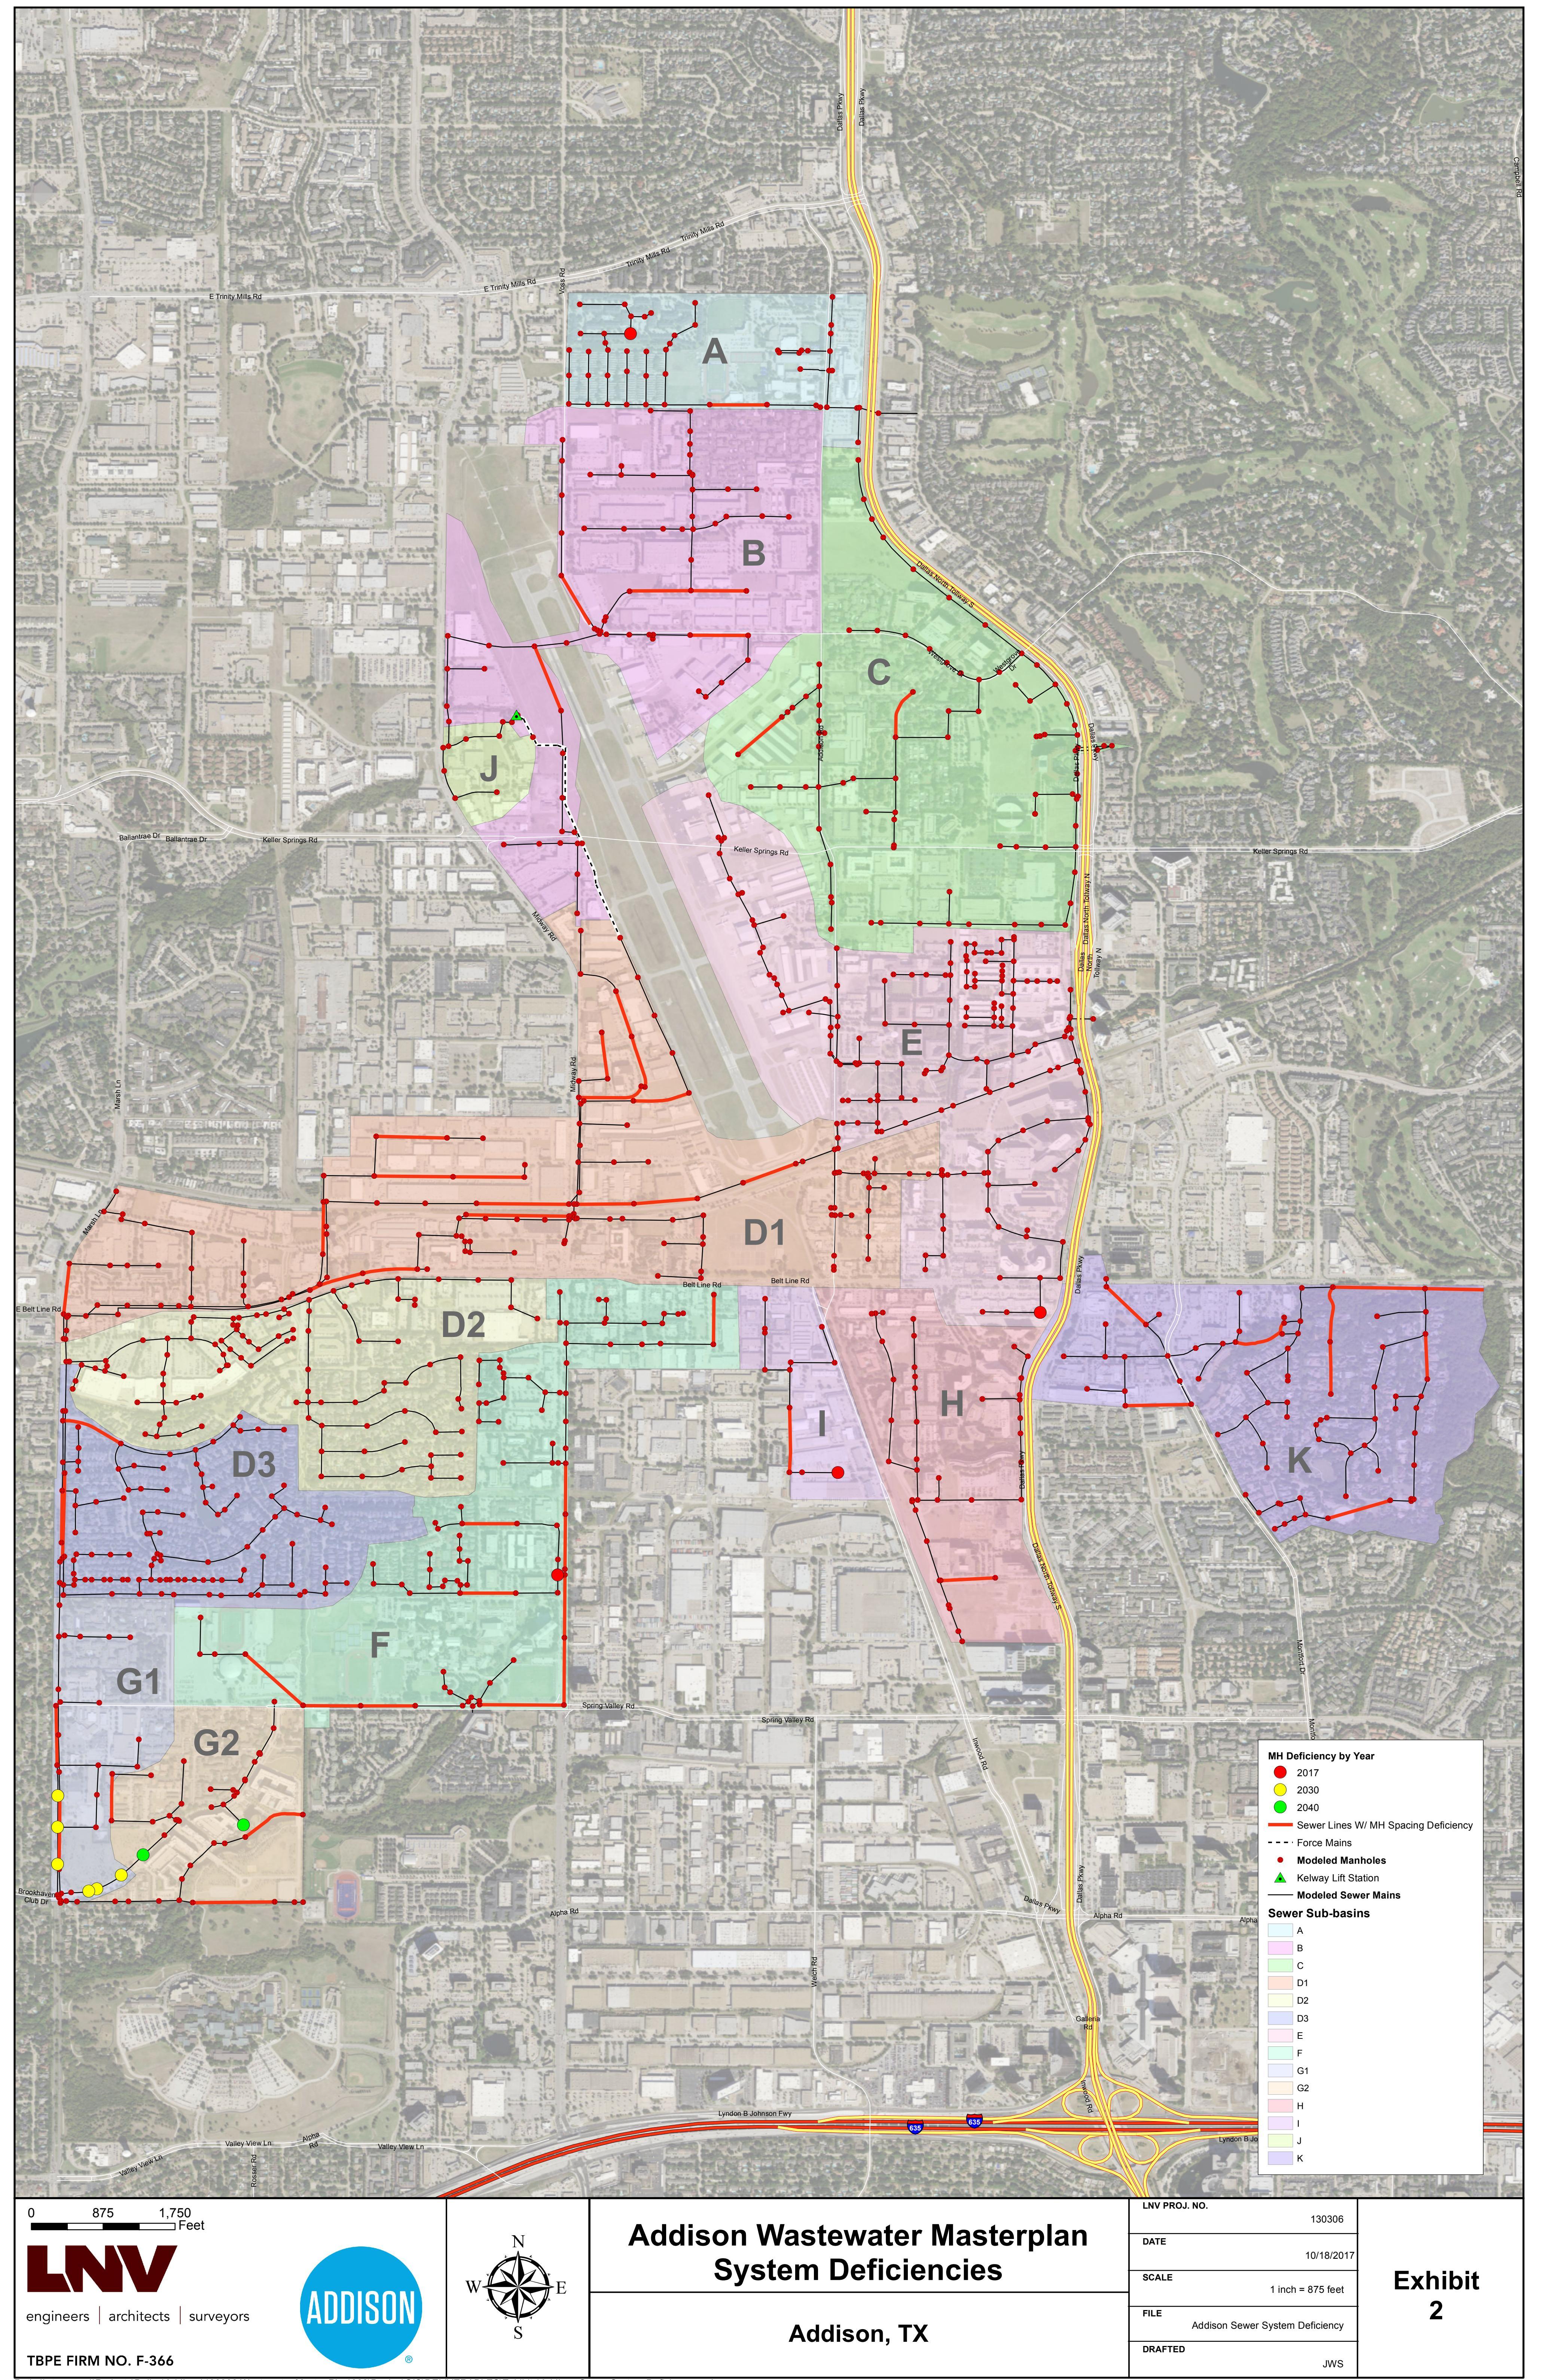
Exhibit 2

System Deficiencies

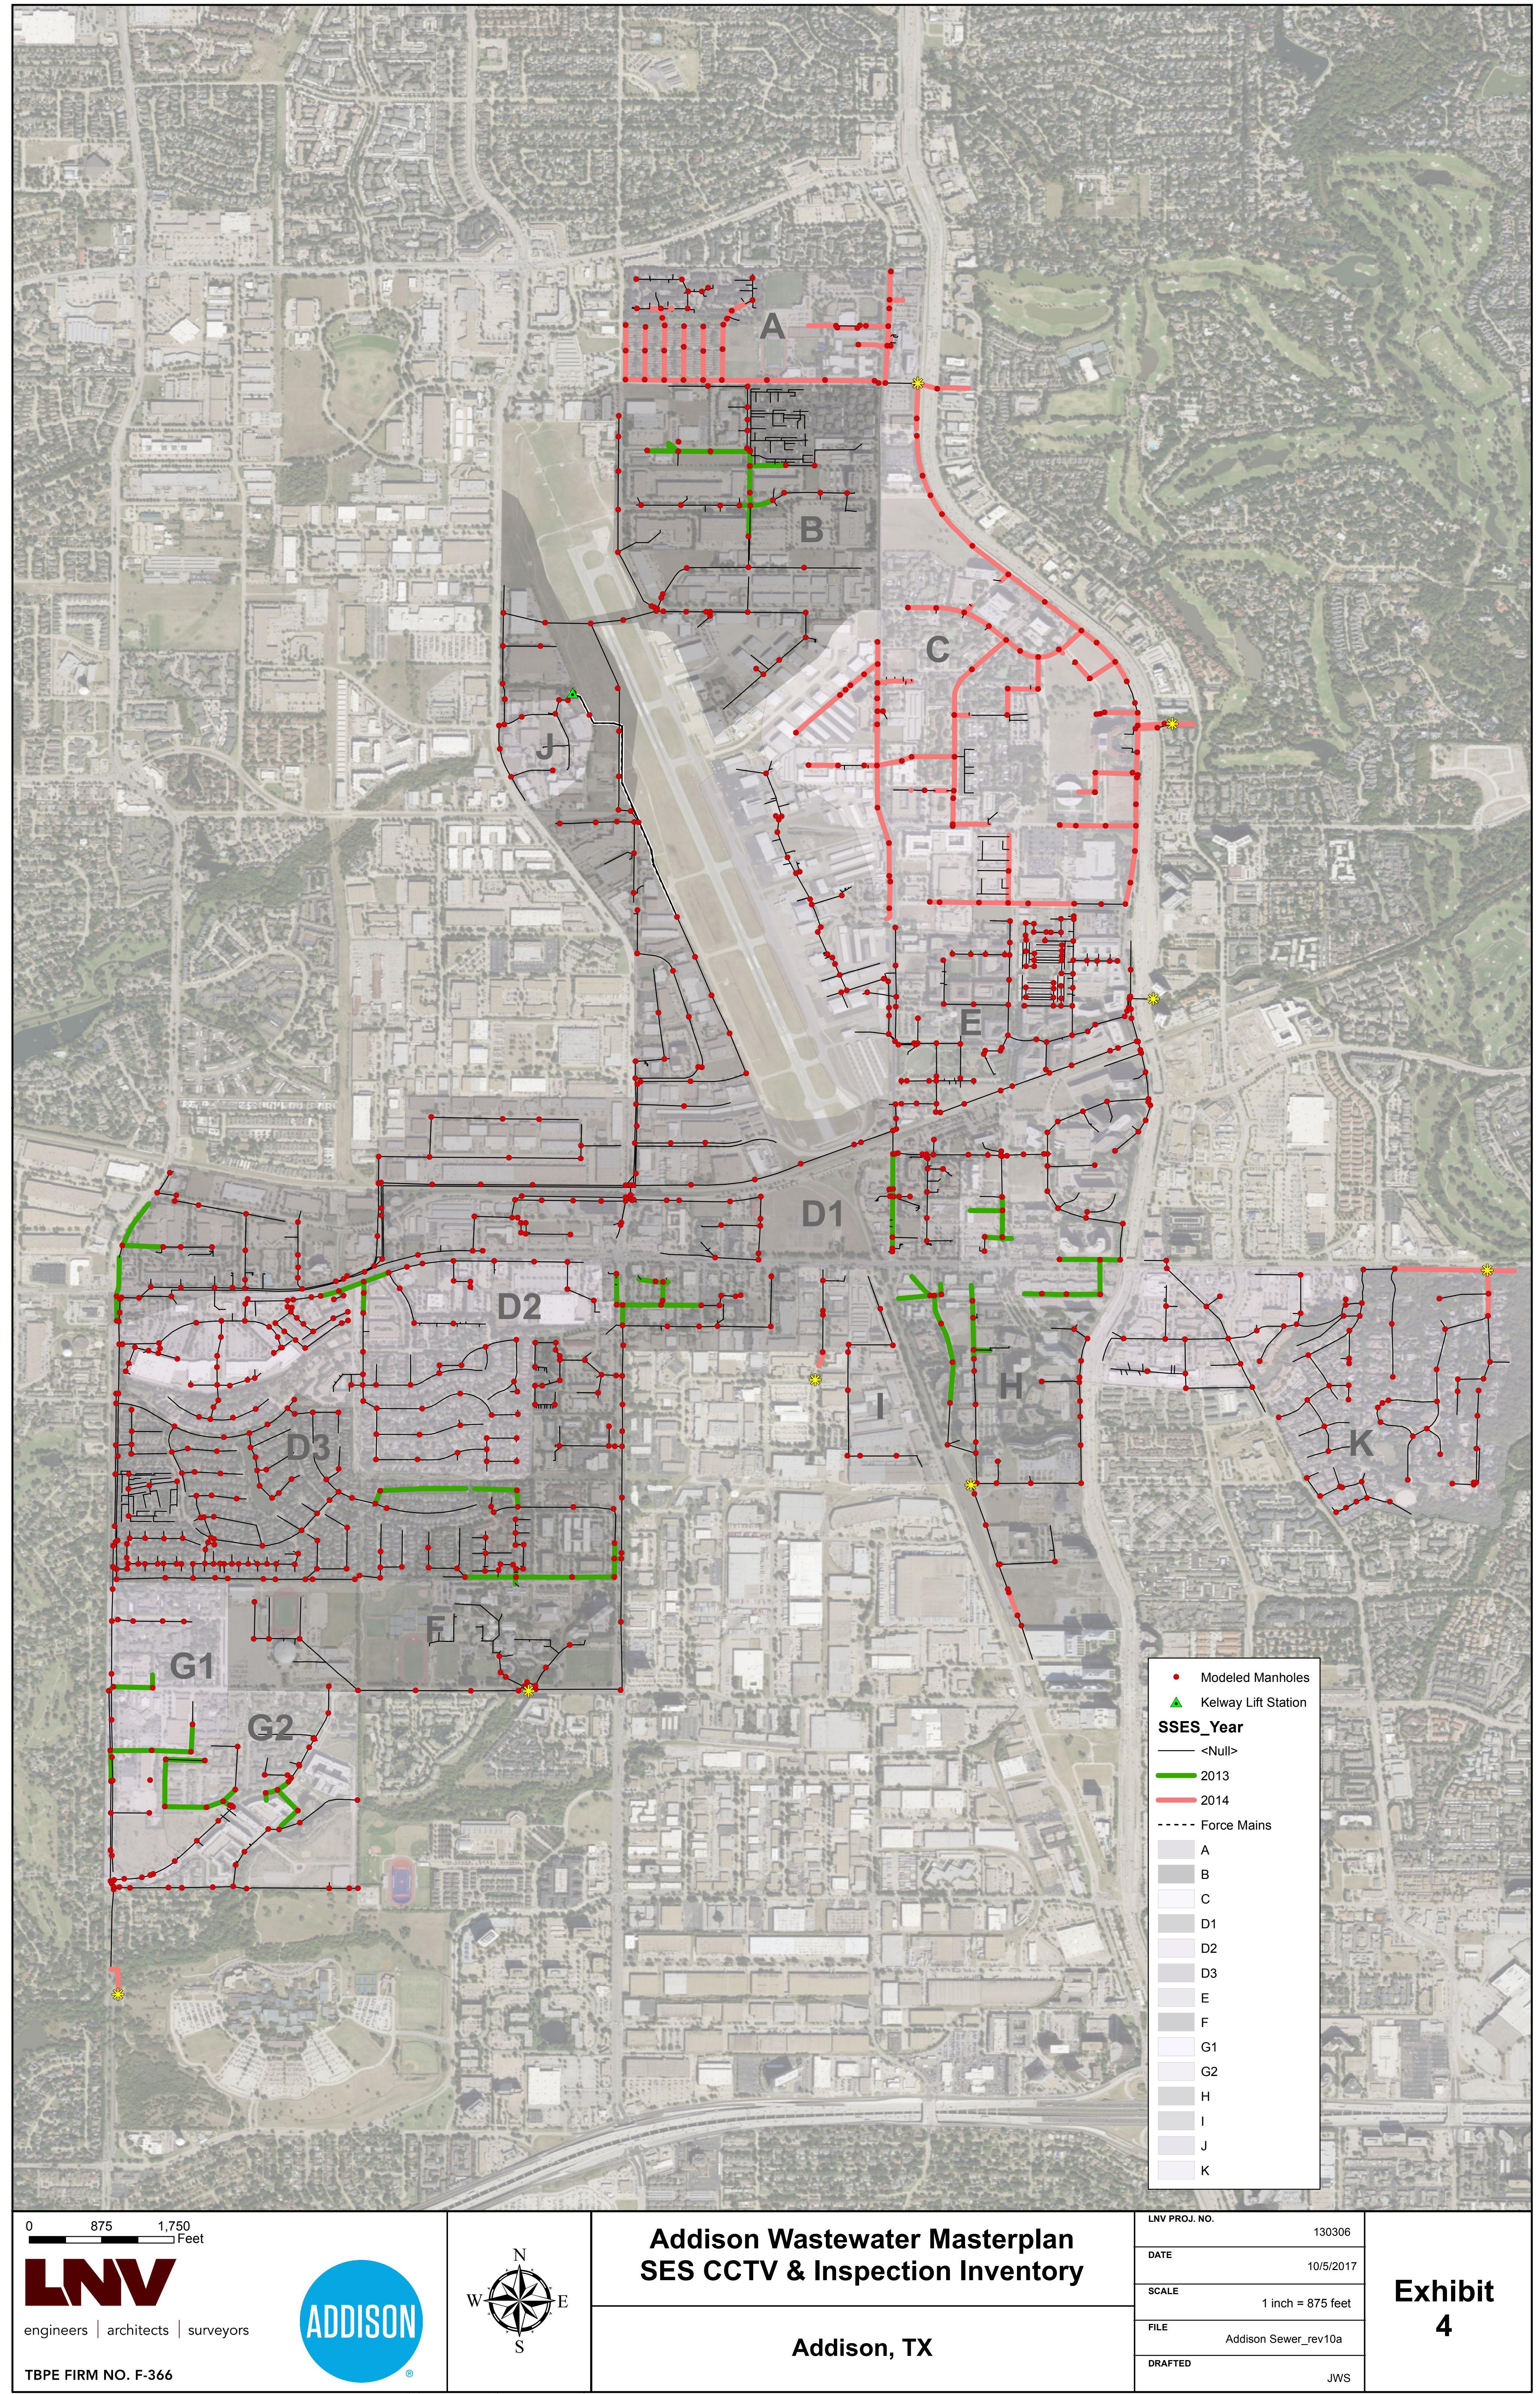
Exhibit 4

As evident in **Table 5**, there are some considerable data gaps associated with overall CCTV inventory that could be addressed by implementing an annual CCTV inspection program. Having assessed 18% of the system under this scope of work provides a good foundation of field assessment that can be built upon during future CCTV efforts.

SSES CCTV & Inspection Inventory
